# Manhole Inspection Summary

Manhole # S33EE\_063MH

Record Plat: **33EE** Node: **063** Status: **Found**

**Location** Address: **1010 PARK AVE**

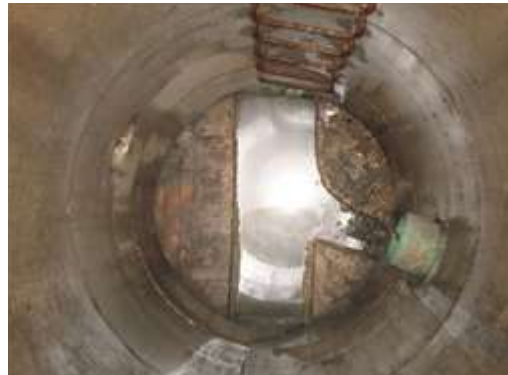
Top View

Corroded steps. Bench debris.

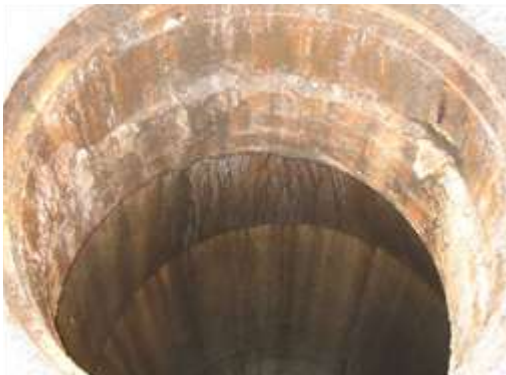
Defect

Frame leaks. Adjustment and Corbel infiltration.

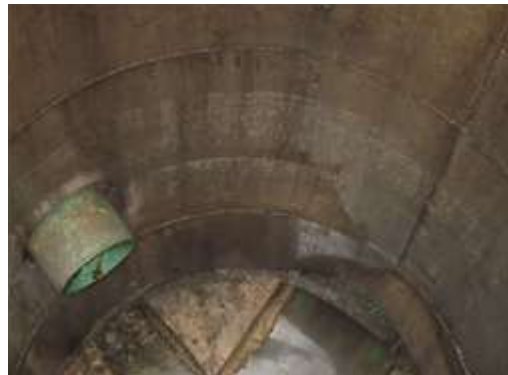
Defect

Barrel infiltration.

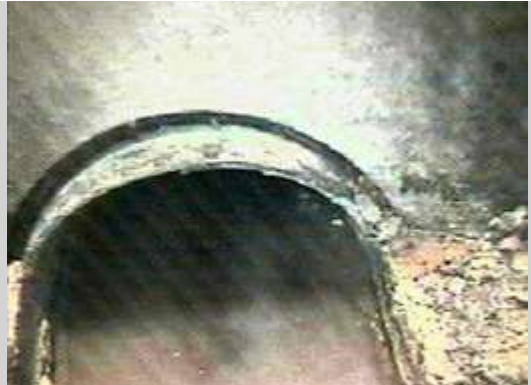
### 18 in. Circular Gravity Sewer Pipe Out @ 12 O'Clock

Infiltration: **Evidence** Pipe Seal Cond: **Unknown**

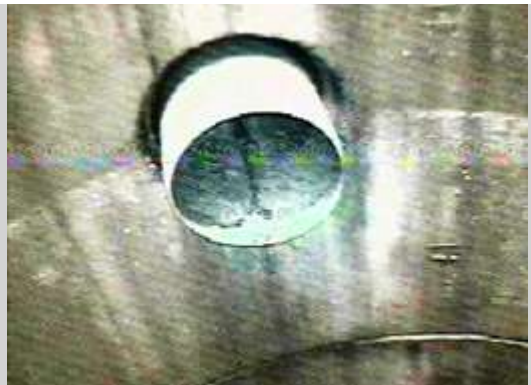
### 8 in. Circular Gravity Sewer Pipe In @ 4 O'Clock

Deposits: ☐ None ☒ Mud ☐ Sludge ☒ Debris ☒ Grease

Silt Depth: **4** (in.) Deposits Extent: **Medium**

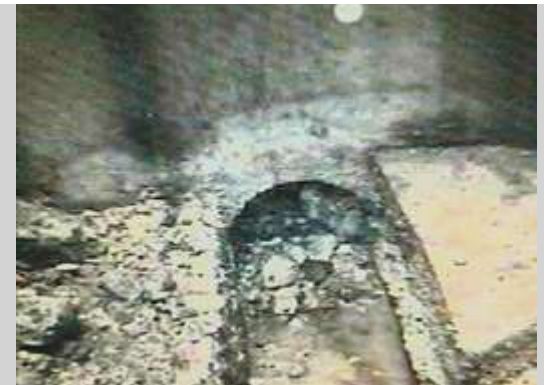
### Drop In @ 4 O'Clock

Channel debris.

Drop Condition: **Partly Clogged**

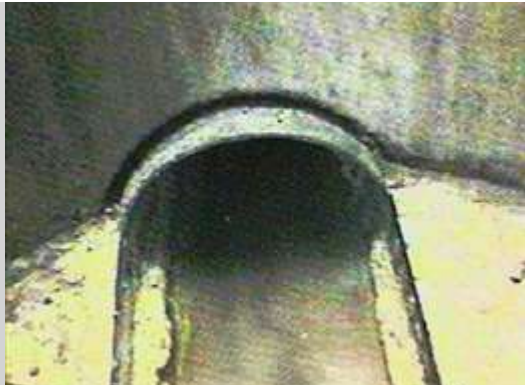
Pipe In @ 6 O'Clock

Grease in the Channel and inside the pipe.

Infiltration: **Evidence** Pipe Seal Cond: **Unknown**
